To: Kevin Hansen, PE City of Columbia Heights
 From: Cindy McCleary, AIA LEED AP
 Date: January 3, 2019
 Re: Columbia Heights City Hall; facility condition report

Columbia Heights City Hall Investigation – TOUR 10/30/2018

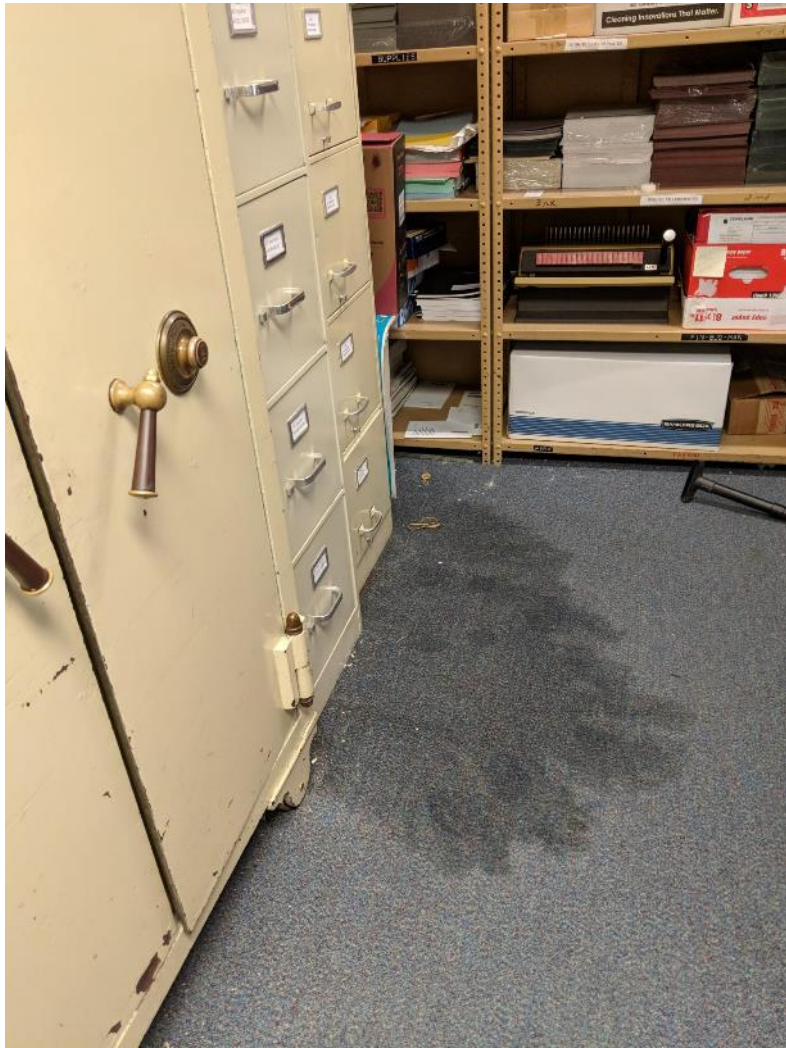
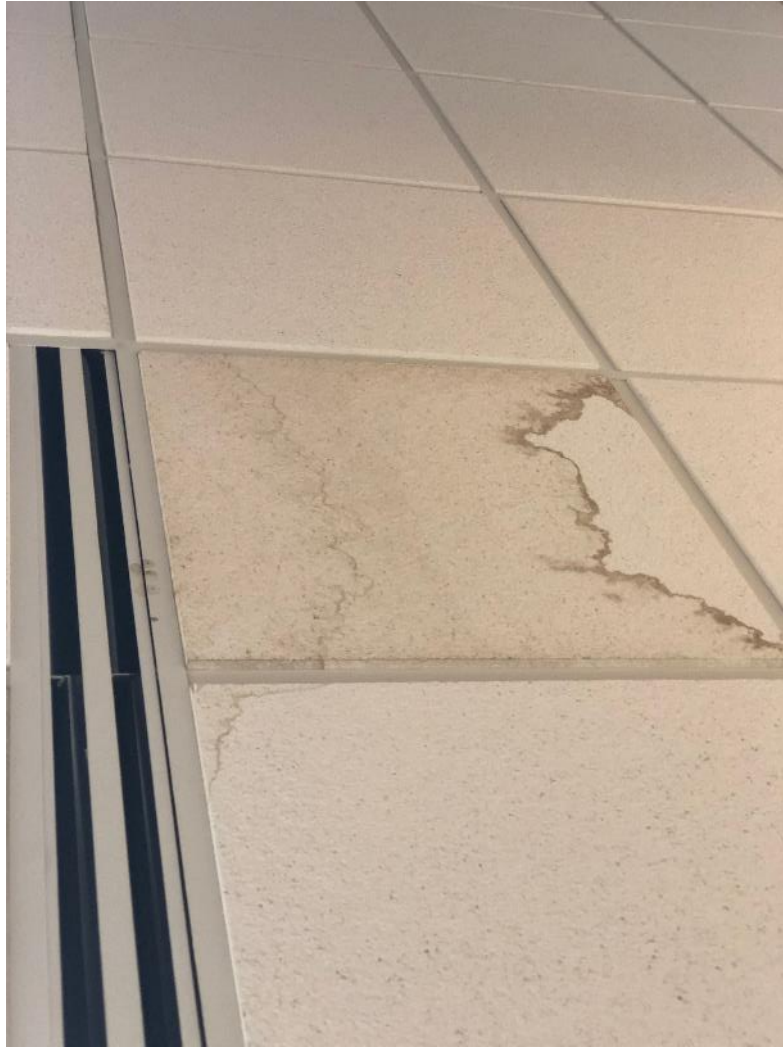
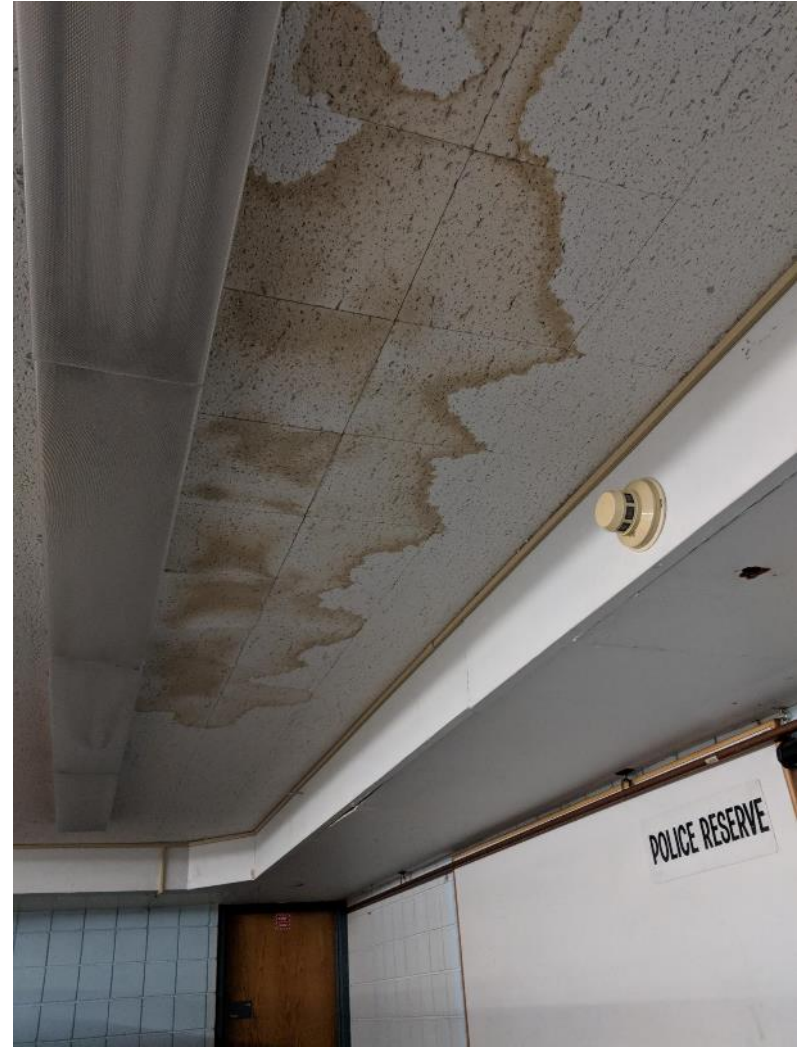
- 9) Water damage; prolific throughout.
 - a) Difficult to distinguish new from resolved conditions however, many conditions appeared to be currently receiving water.

Evidence of Water Infiltration

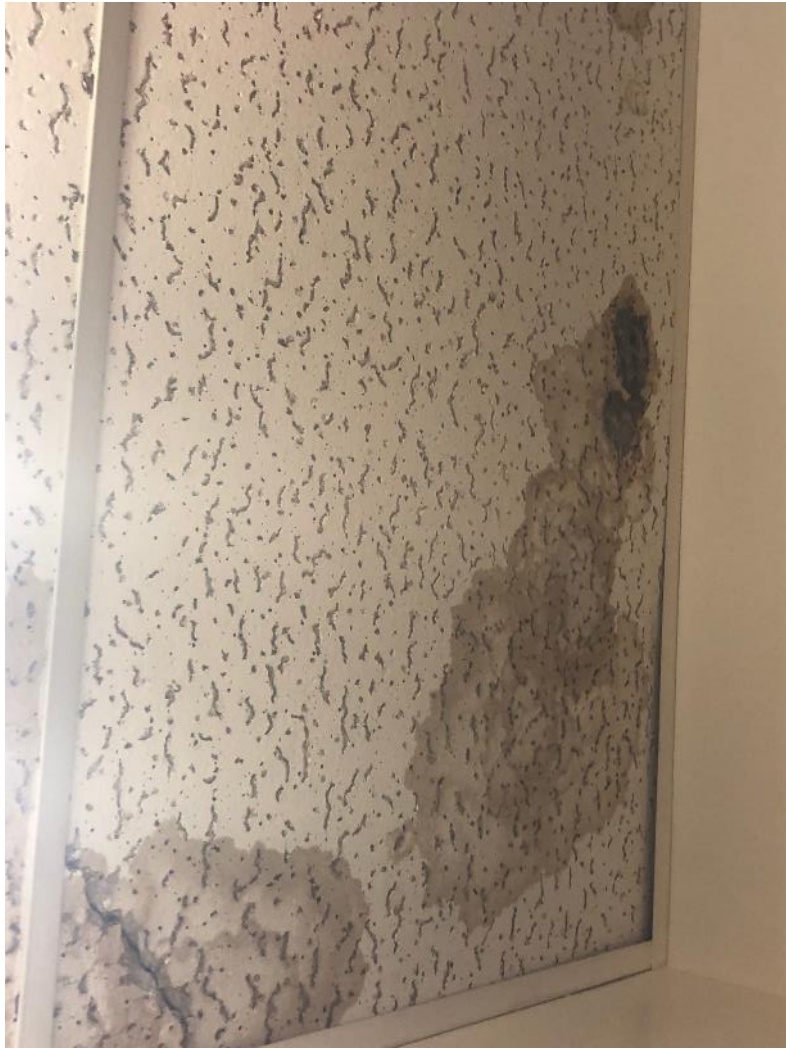
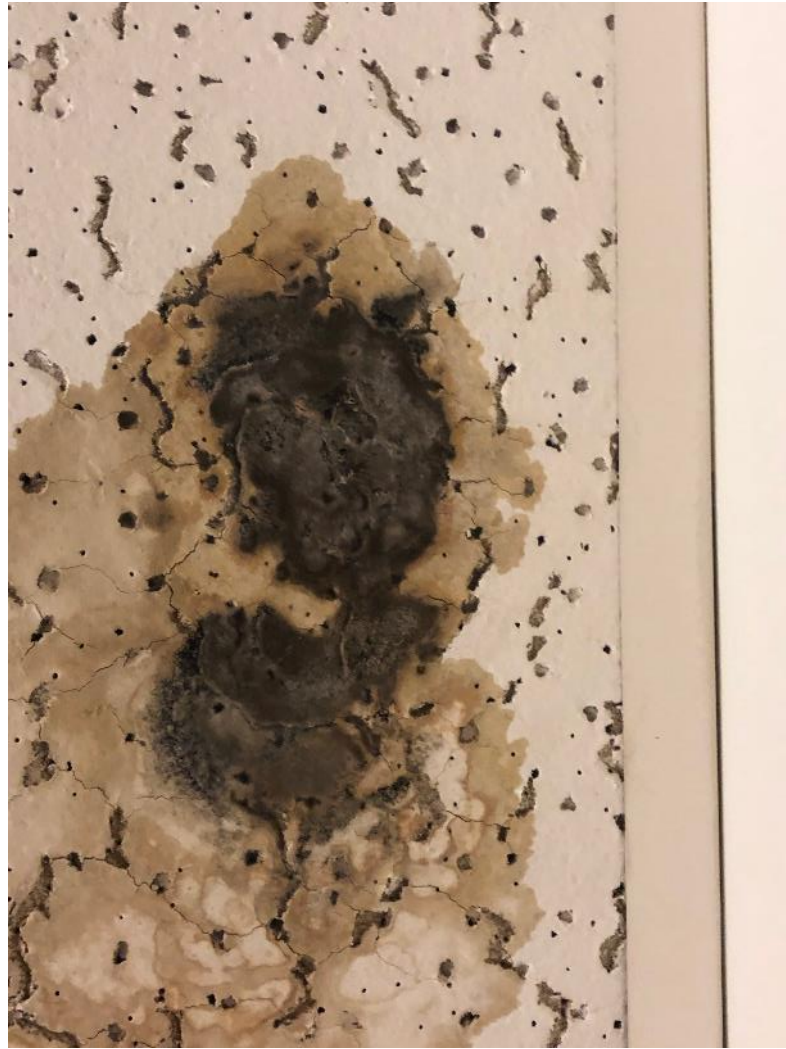
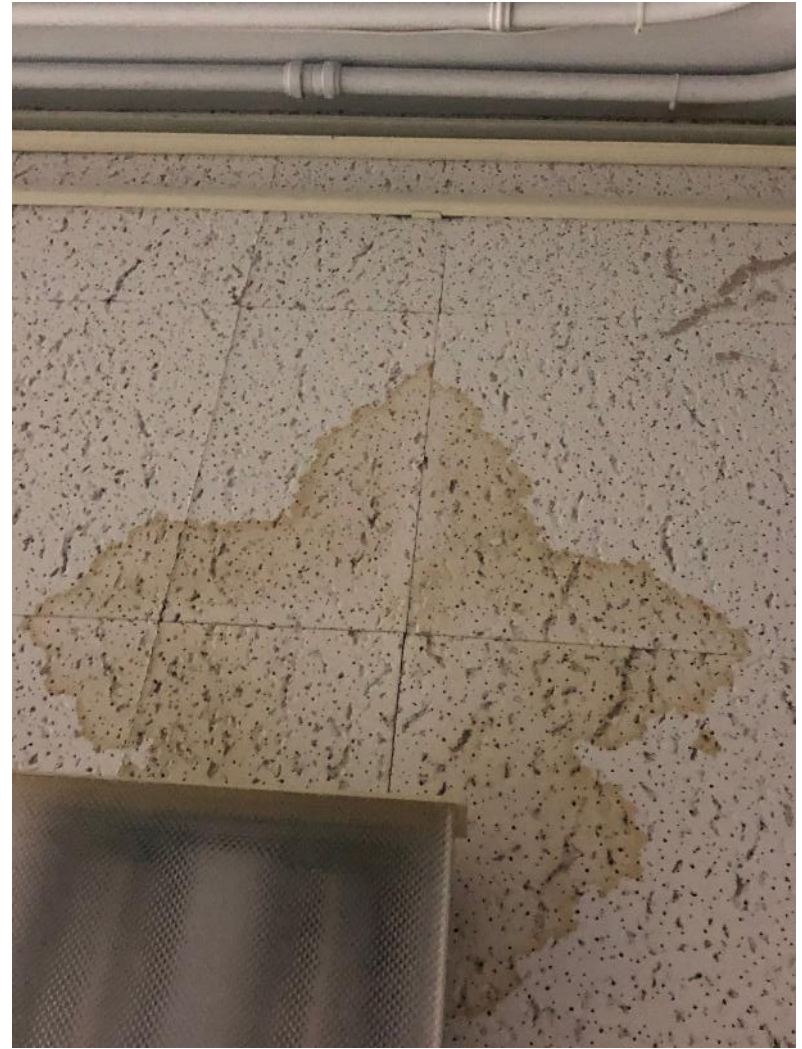
- b) In basement. Mold growing on sheetrock in multiple areas.
 - c) Ceiling tiles. Mold growing on sheetrock in multiple areas.
 - d) In office space near IT room. AC wall unit leaks down into first level offices. Walls being wet potential for mold growth. Deterioration was observed.

Evidence of Water Infiltration

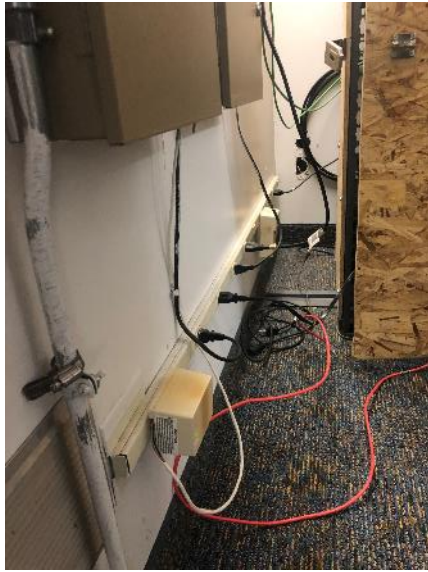
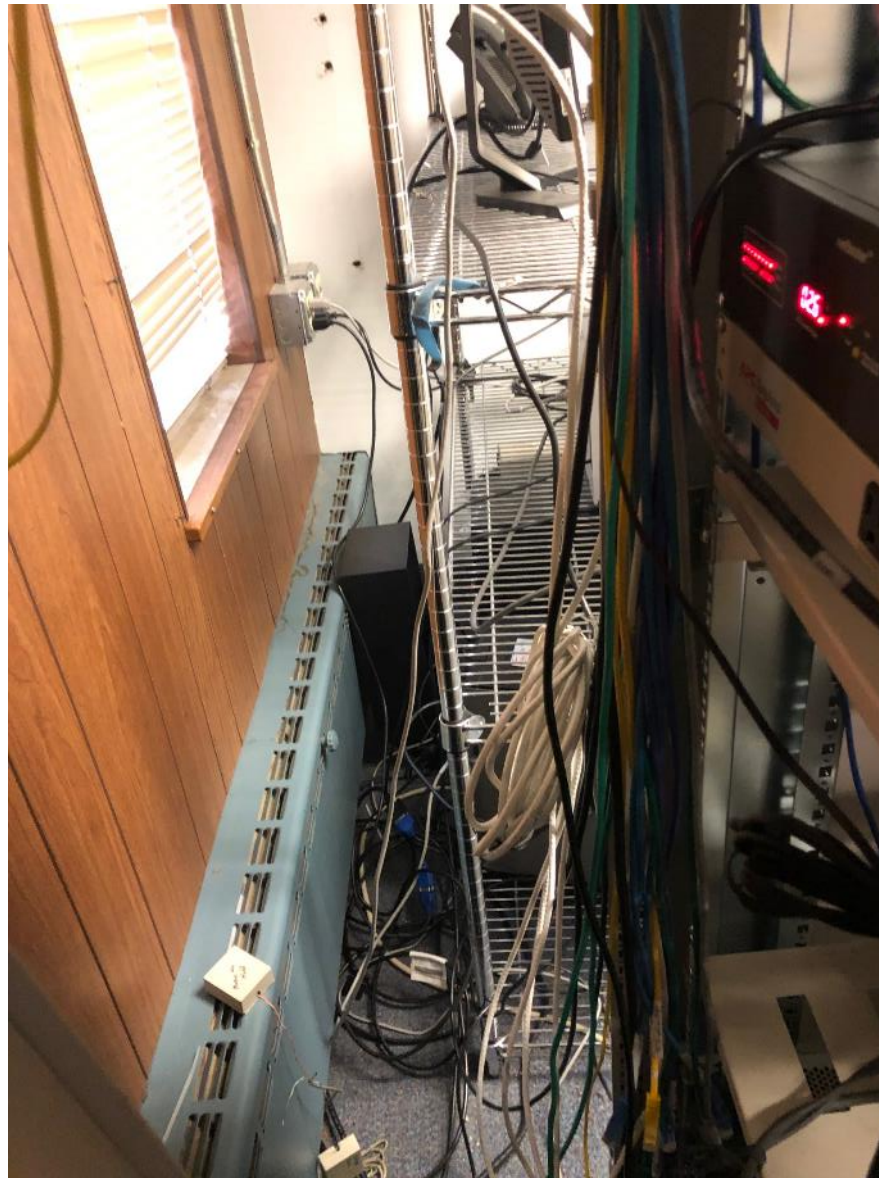
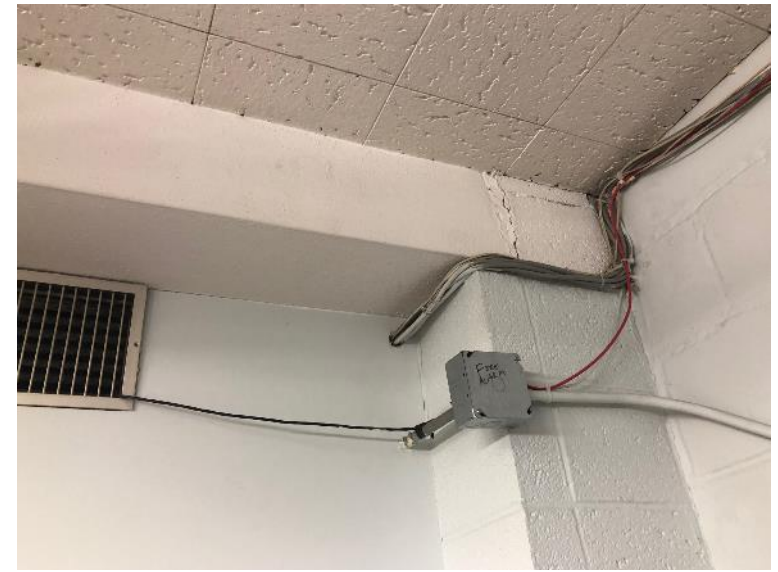
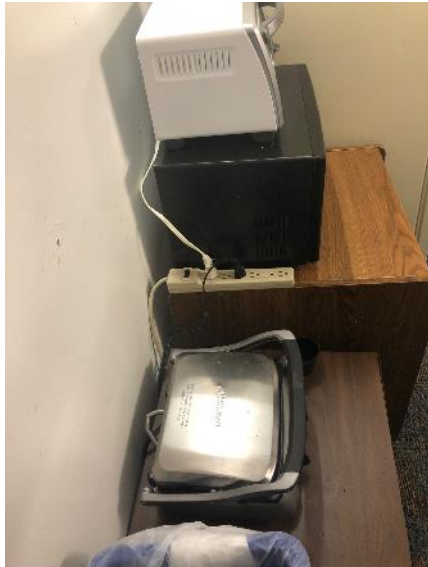
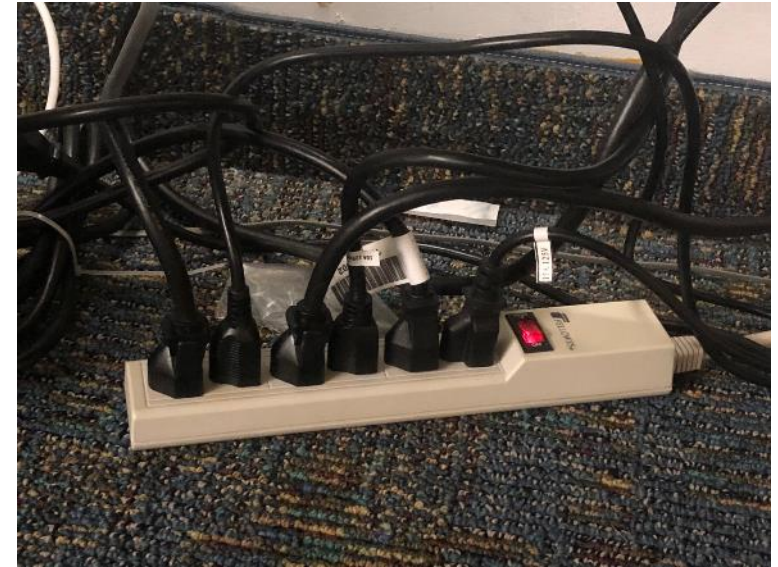
- 16) Microwaves, space heaters and other high draw equipment were plugged into power strips, appear to over-demand the electrical supply.
 - a) Not to electrical code for that many power strips or that equipment supplied from power strip.

Evidence of Inadequate Power Capacity / Wiring Integrity

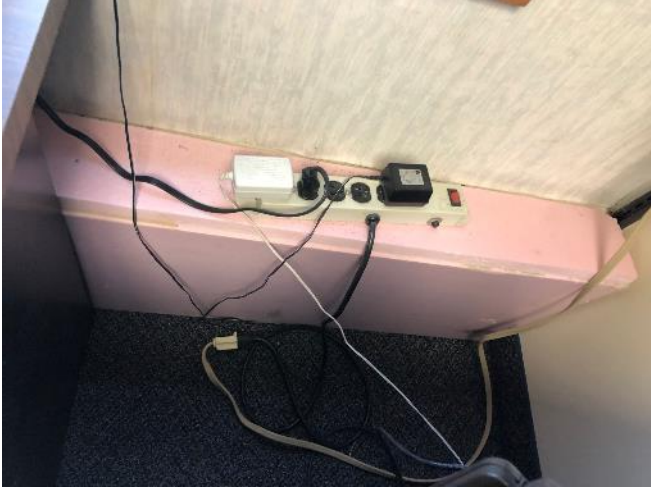
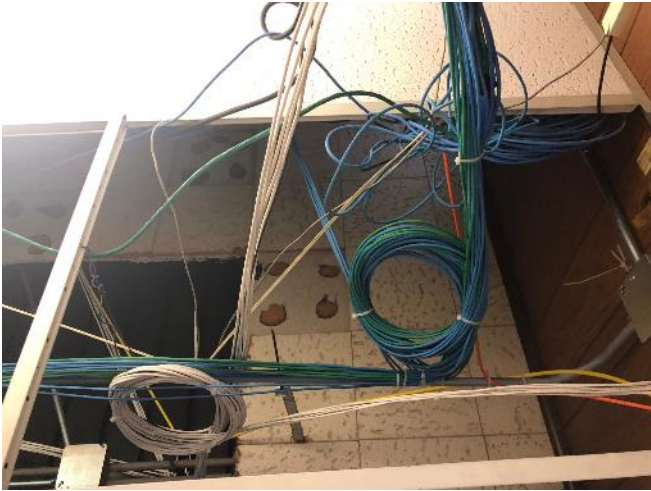
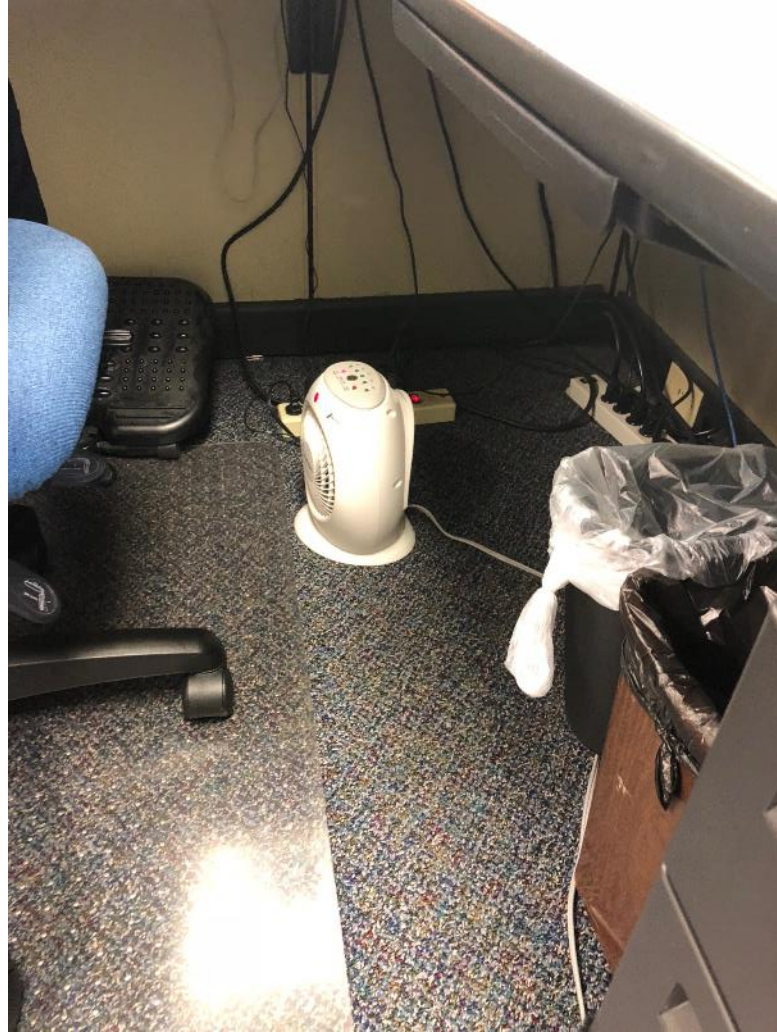
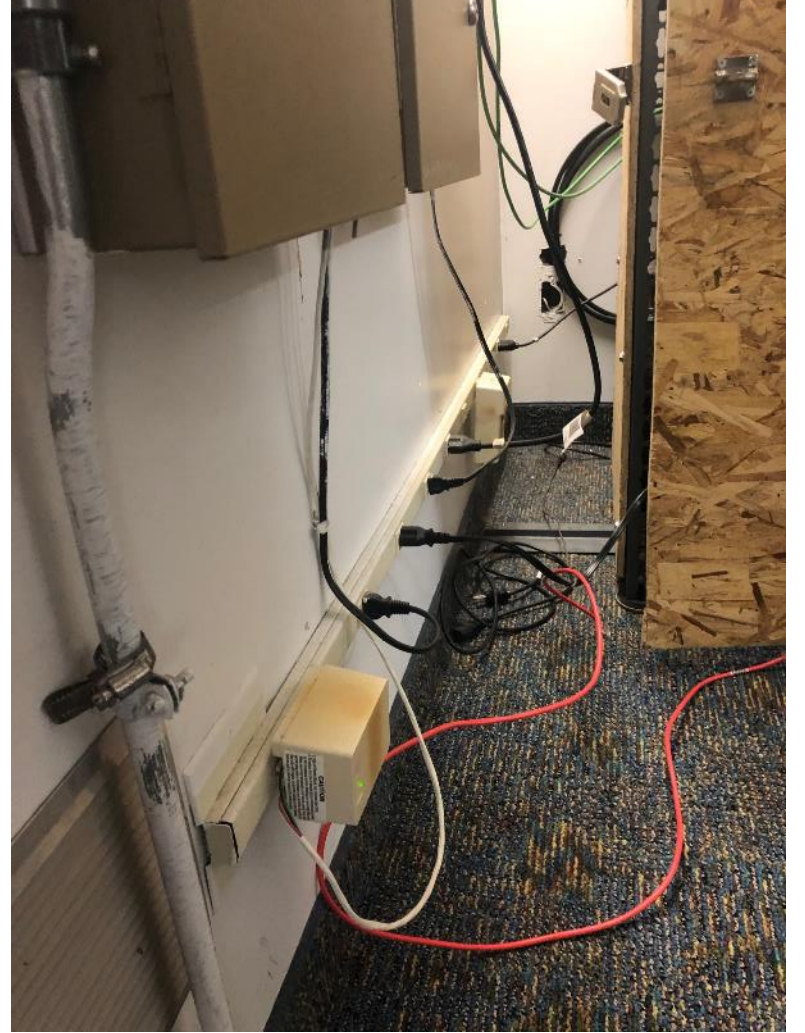
- b) Not sufficient number of receptacles.
 - c) Prolific instances of inadequate power throughout.
- 17) Employee wrapped heater register.
 - a) Some registers were compromised in order for occupant to control heat (one condition in which staff person self-insulated the radiator to avoid heating during summer.)

Evidence of Inadequate Power Capacity / Wiring Integrity

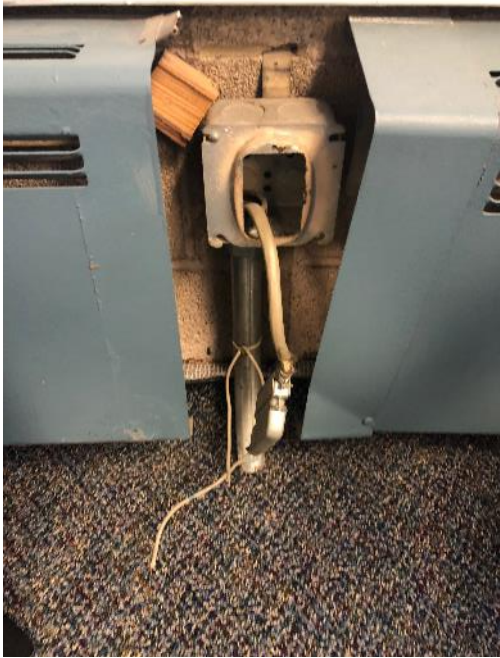
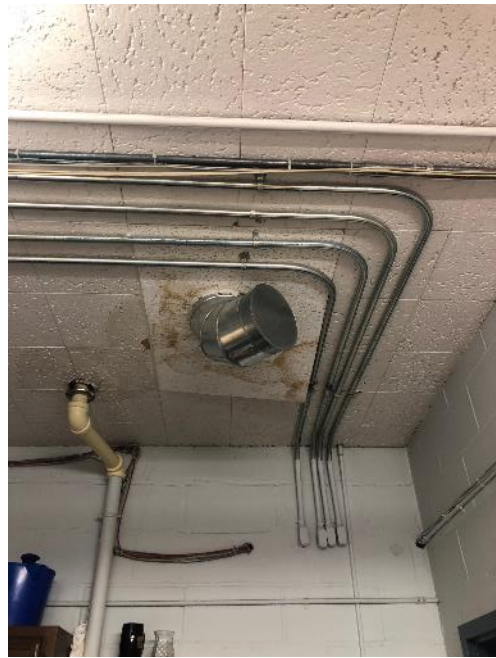
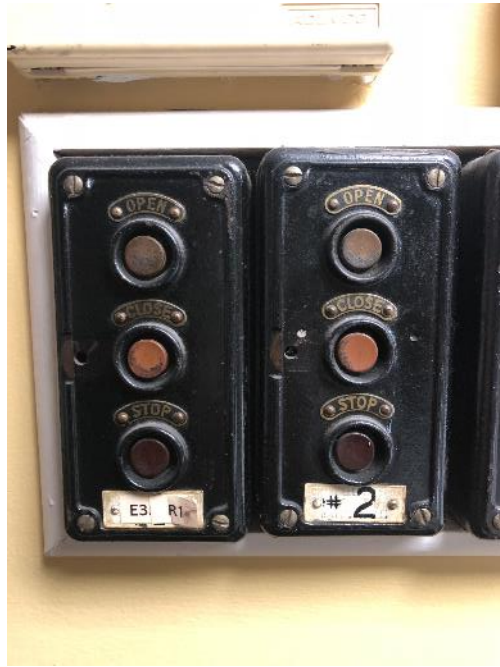
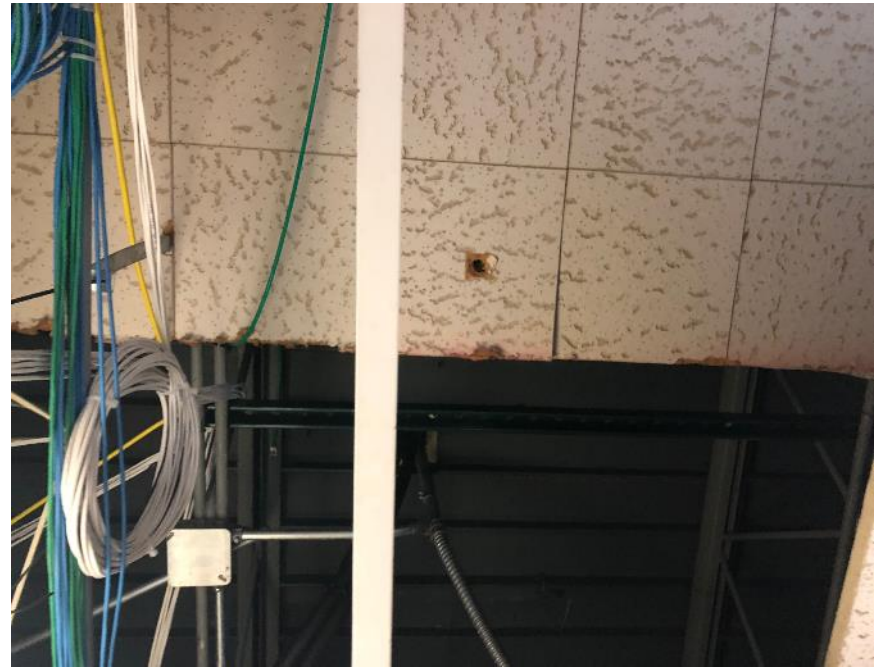
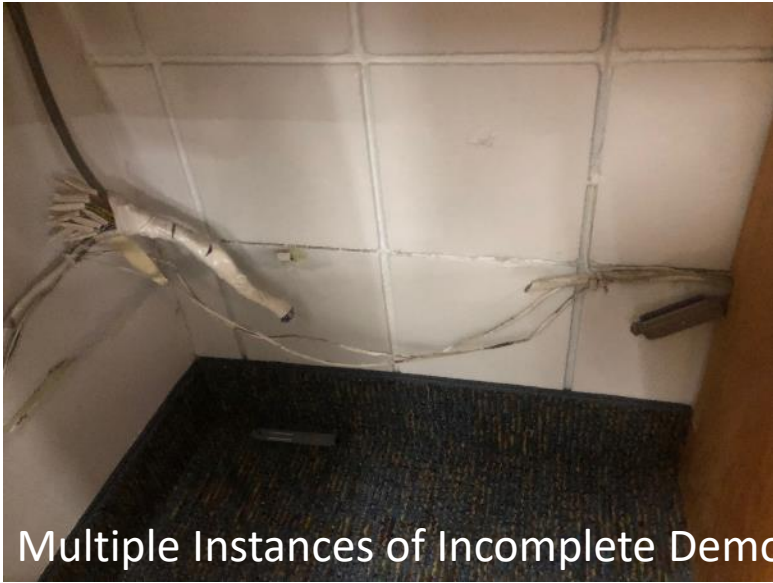
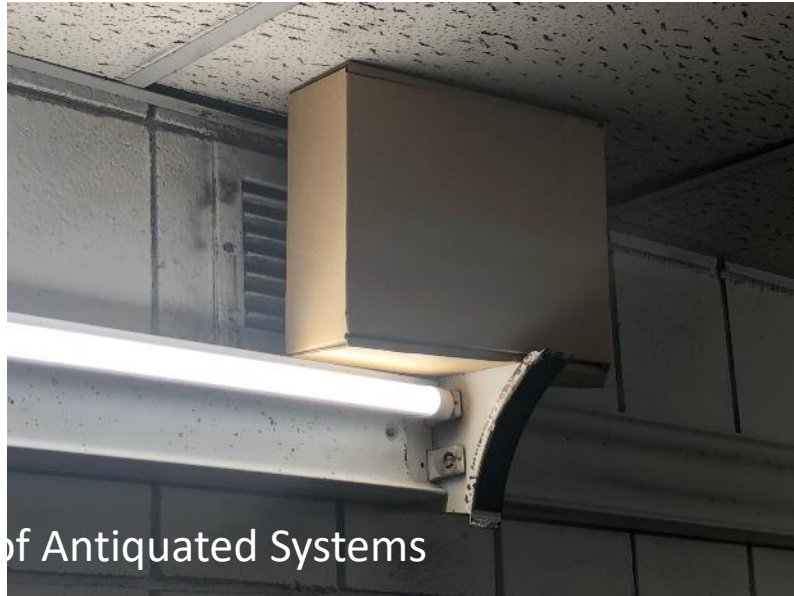
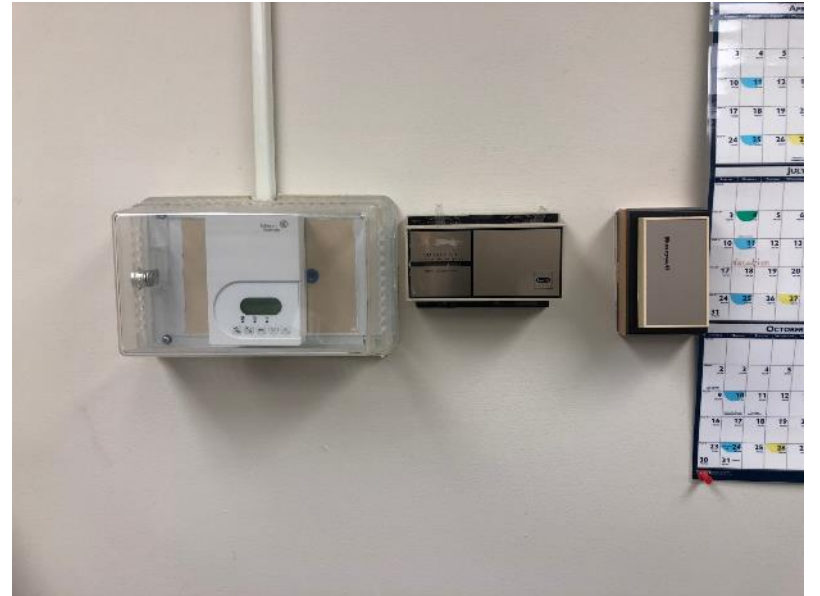
- b) Areas of partially demo'd systems, including removal of pipes but the hole through walls still remains open, or conduct without box cover. These conditions could be potential fire pathway or hazards and should preventatively, minimally be covered.

Multiple Instances of Incomplete Demolition of Antiquated Systems

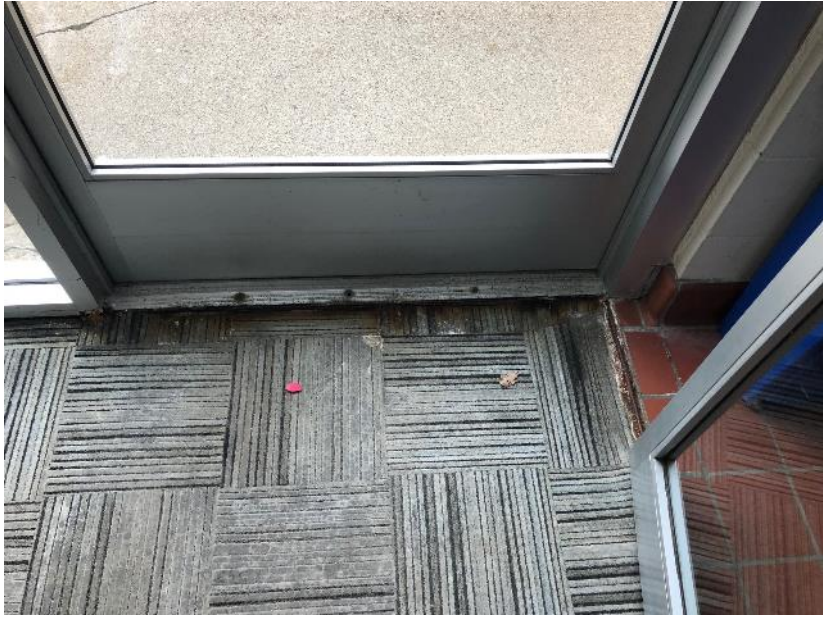
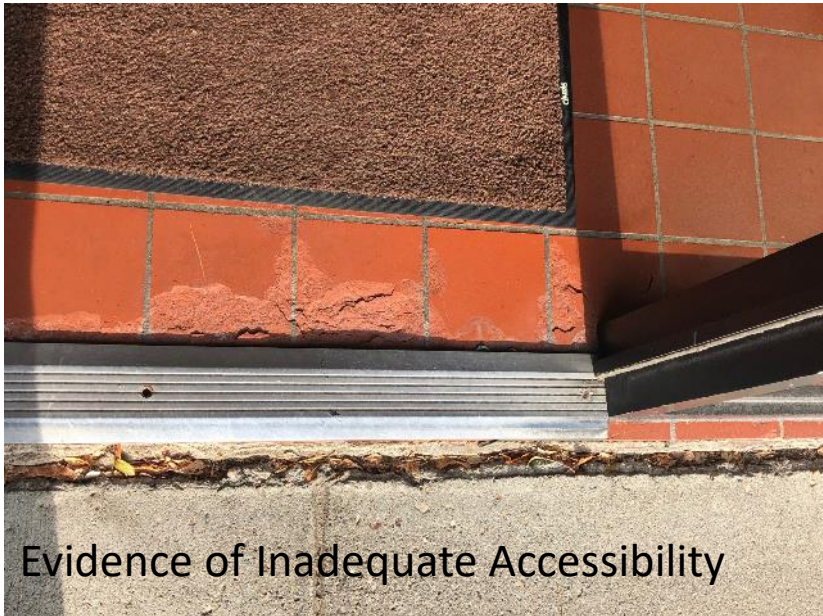
- f) IS office (former public safety) floor levels do not support access by the current elevator. To achieve accessibility a second elevator requires entering through a garage stall. This does not meet ADA guidelines.

Evidence of Inadequate Accessibility

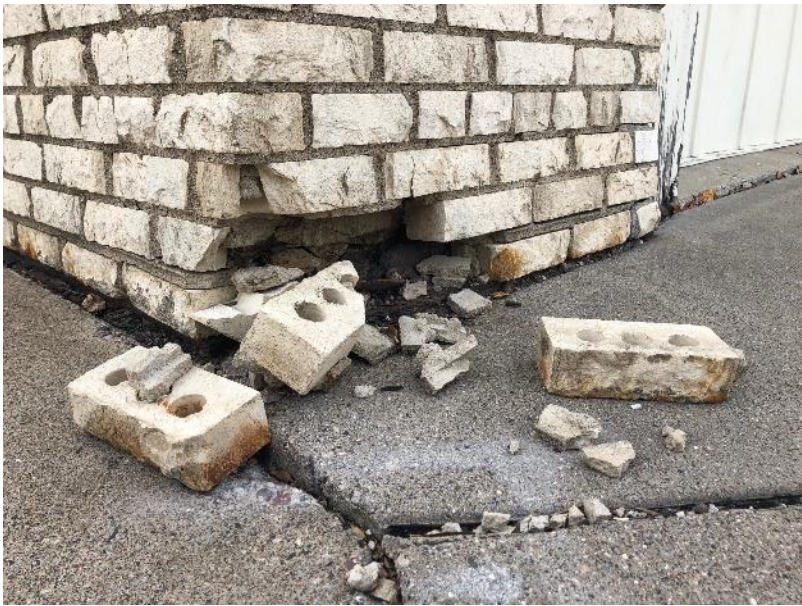
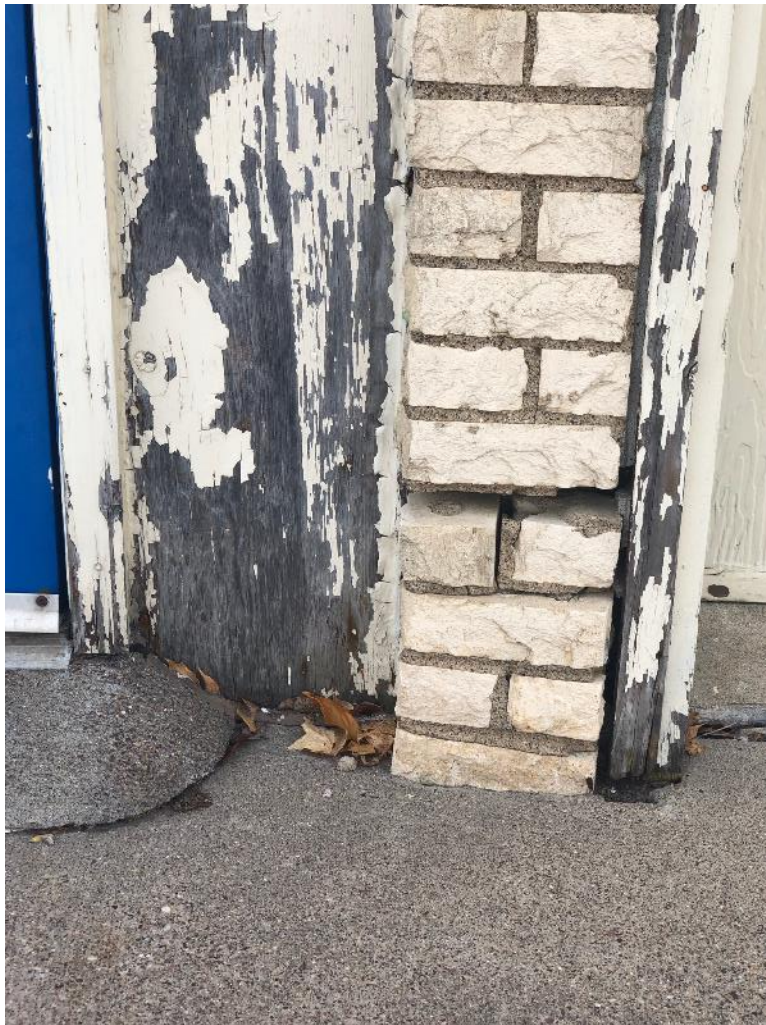
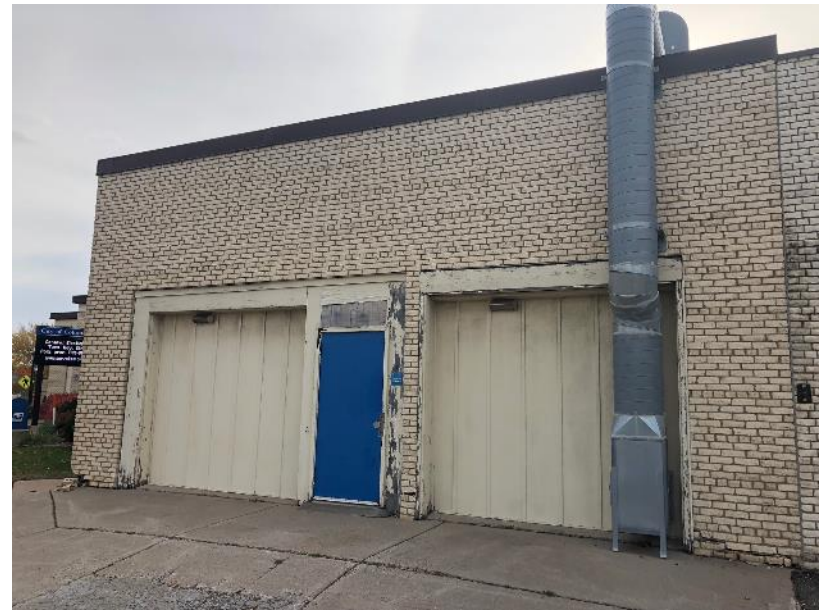
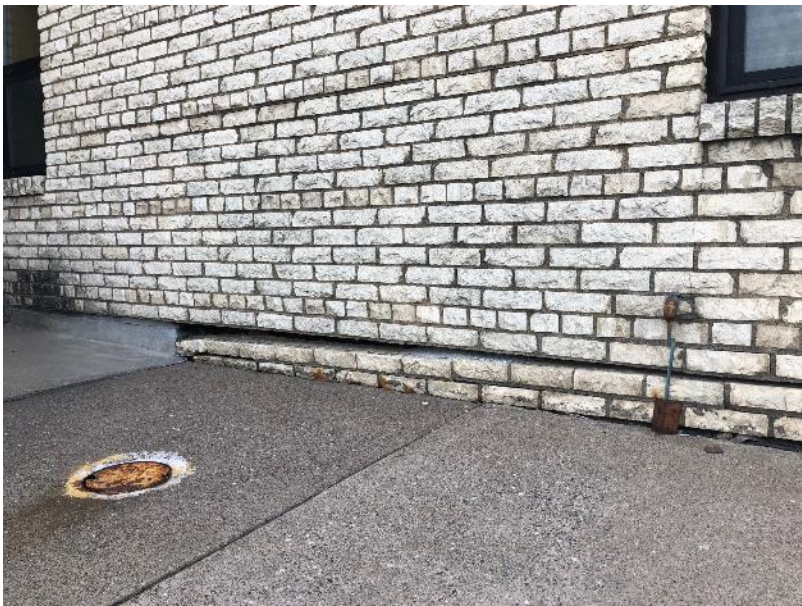
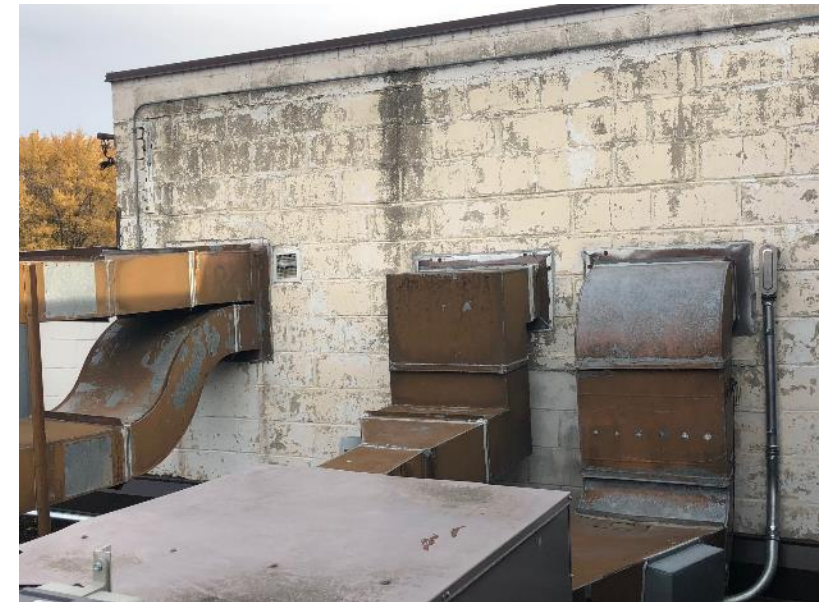
- a) Brick failure is significant on north side of building. Water infiltration is likely. Did not review structural system, however, exterior wall system appears to be composite CMU/Brick construction without air space, vapor barrier or insulation resulting in transfer of heat and cold without thermal break, transfer of water interior to exterior.

- b) IT appears by the wall construction that no exterior wall insulation is present. Not code compliant.
 - c) Cinderblocks cracking showing deterioration, movement and water transmission. Due to wall construction, these conditions can be mitigated with products but not resolved due to antiquated exterior wall system, no insulation, vapor barrier or air space.

Evidence of Exterior Wall Failure

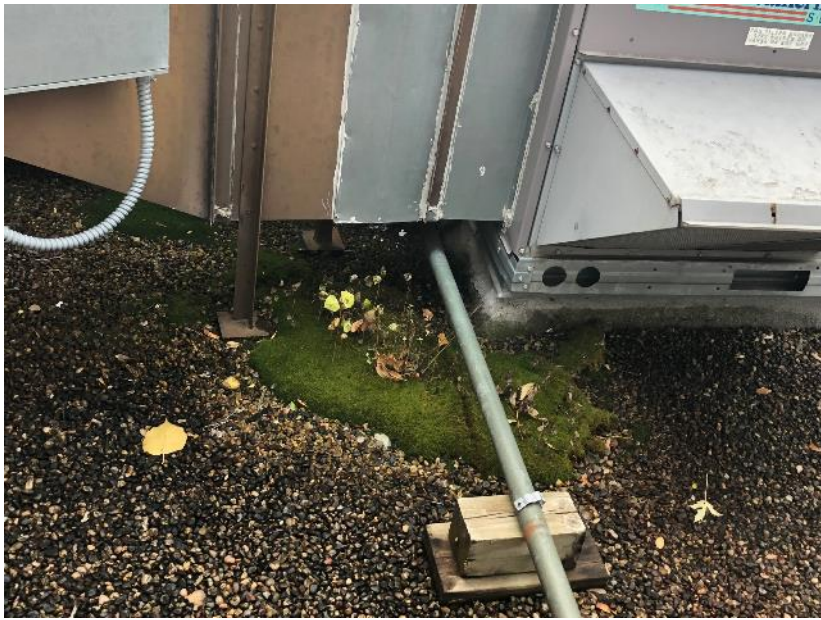
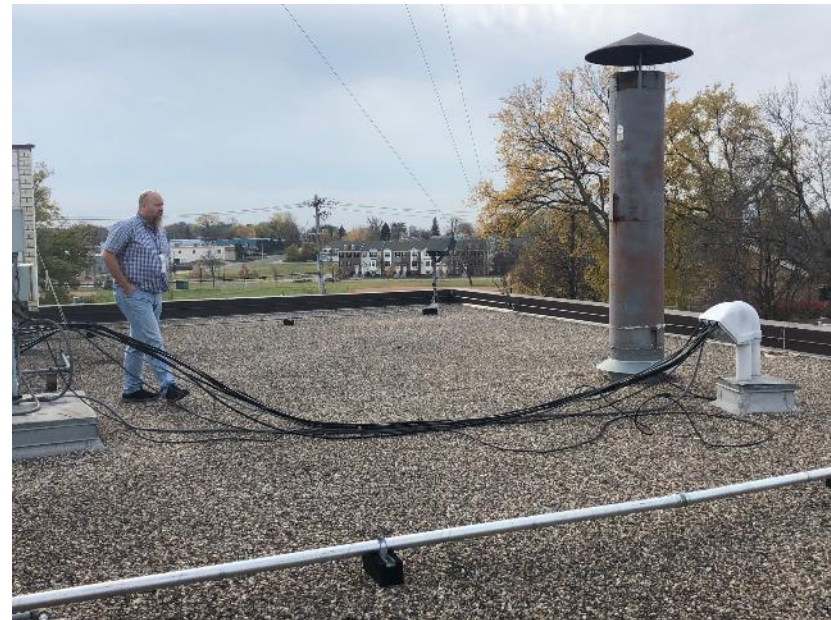
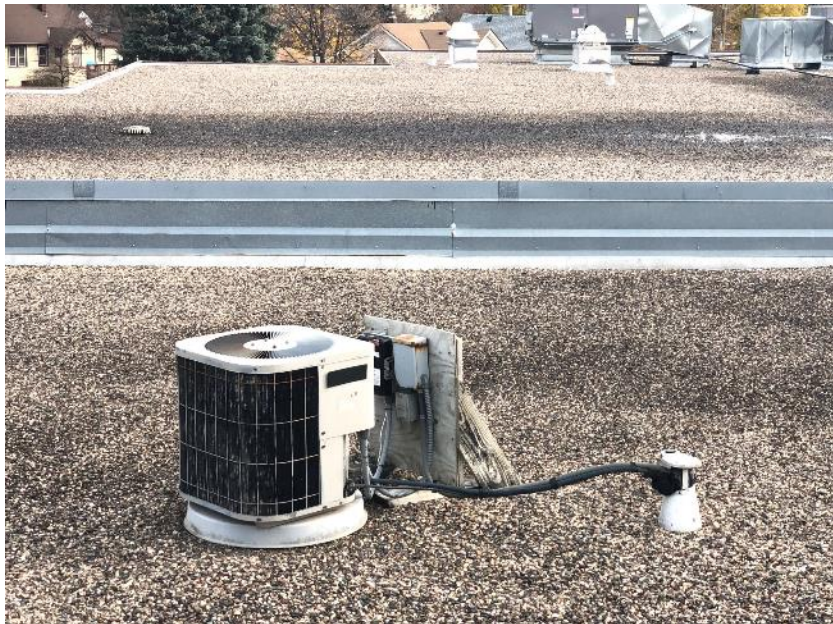
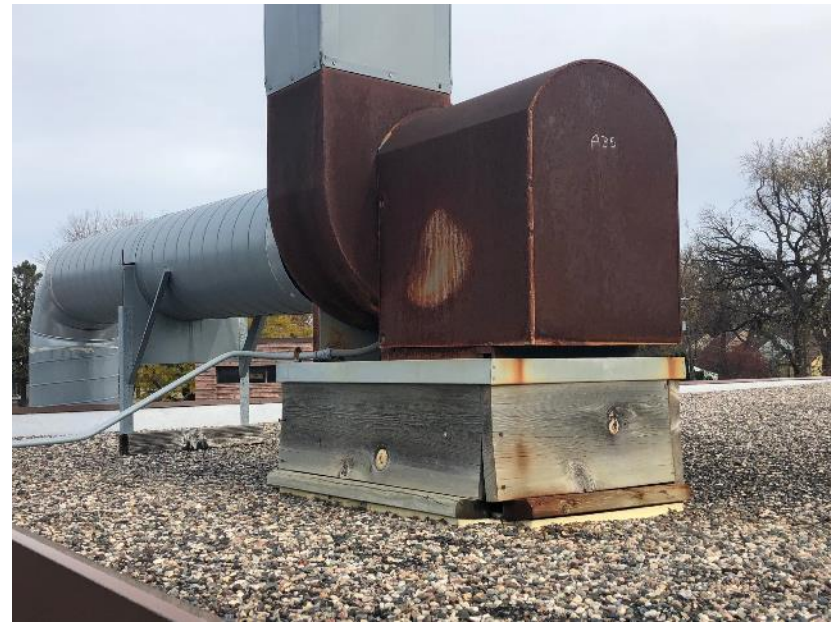
- 11) Roof replacement
 - a) Staff noted the project to be scheduled in 2020. Roughly \$600K estimated.
 - b) Water standing on roof, not draining correctly.

- c) Vacated equipment appears to be present (police radio tower and potentially other) and should be removed.
 - d) Cabling is inadequately run across the top of the roof with no protection to either.

- e) Mechanical curbs appear to be mounted to roof, are exposed wood and not flashed in. These are likely culprits to water infiltration.
- 12) Odd egress pathways out of basement for employees. No emergency elevator or ground level egress.

Evidence of Roof Inadequacy

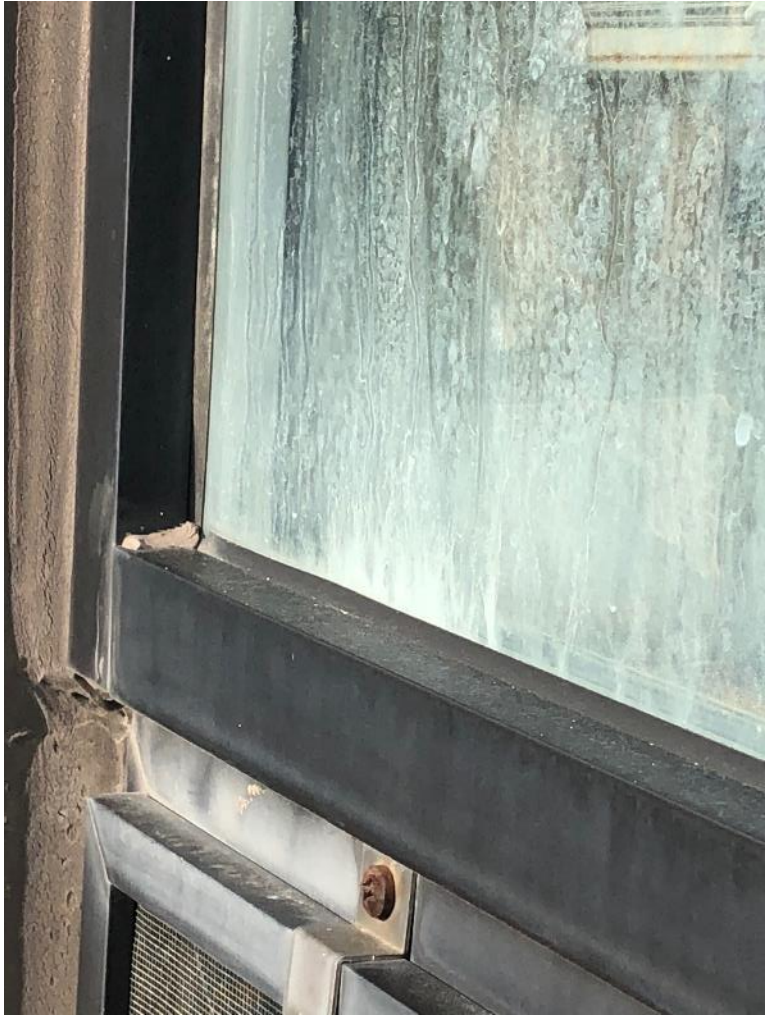
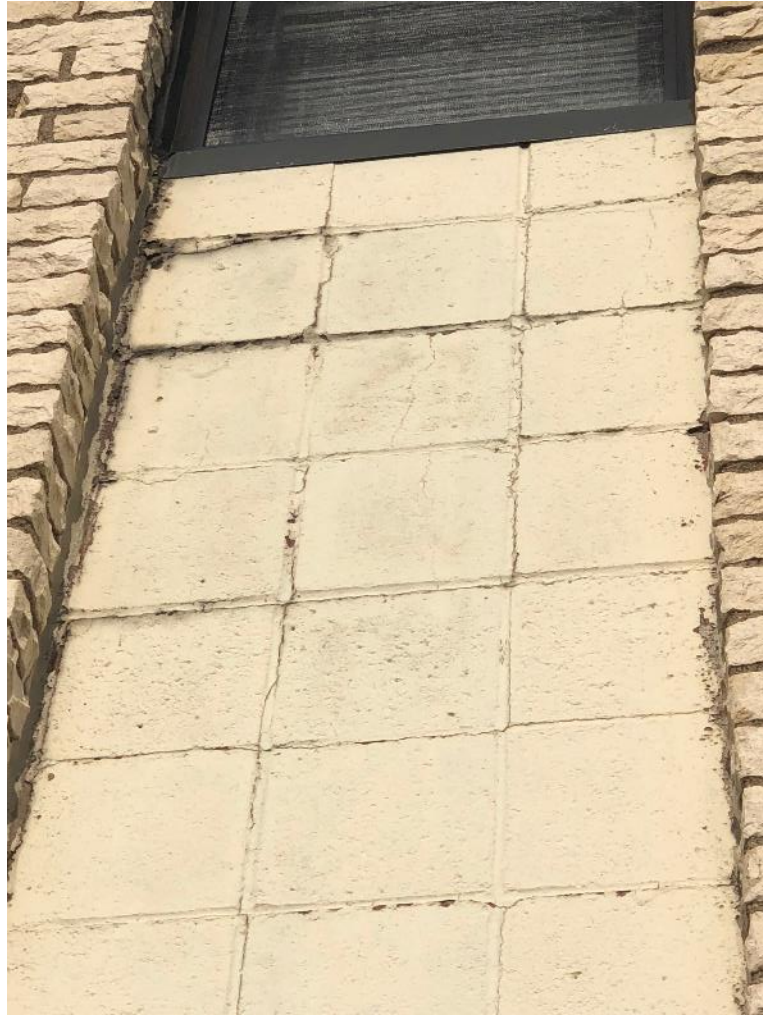
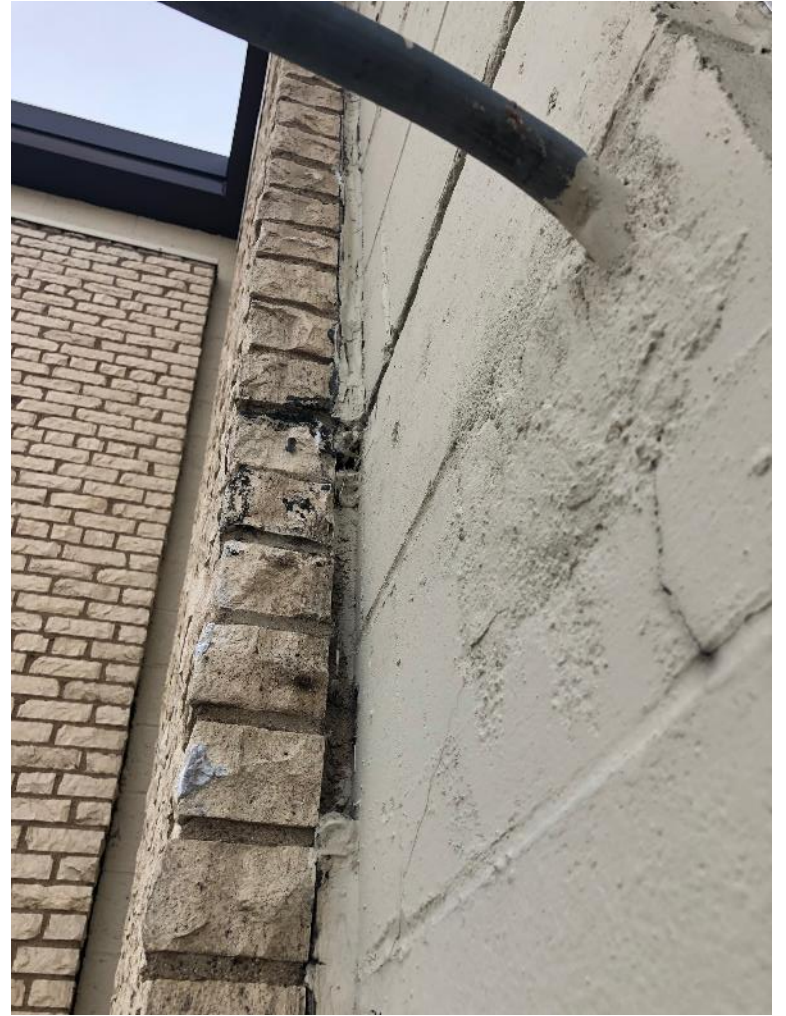
Evidence of Exterior Wall Failure / Water Intrusion
