To: Kevin Hansen, PE City of Columbia Heights
 From: Cindy McCleary, AIA LEED AP
 Date: January 3, 2019
 Re: Columbia Heights City Hall; facility condition report

Columbia Heights City Hall Investigation – TOUR 10/30/2018

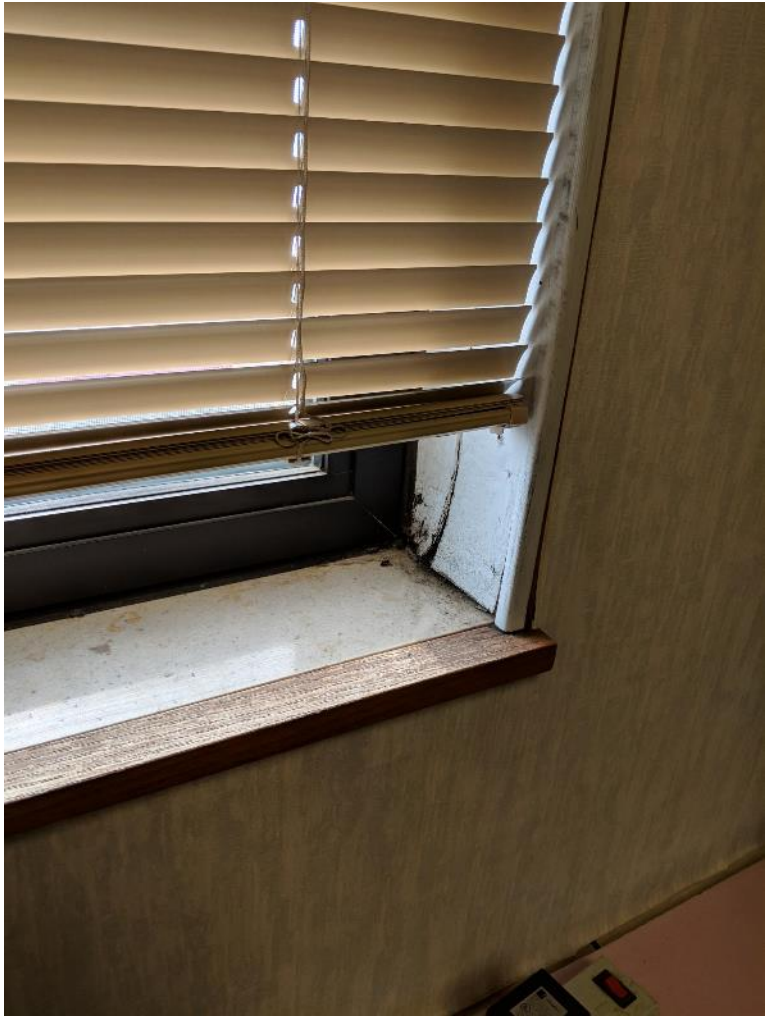
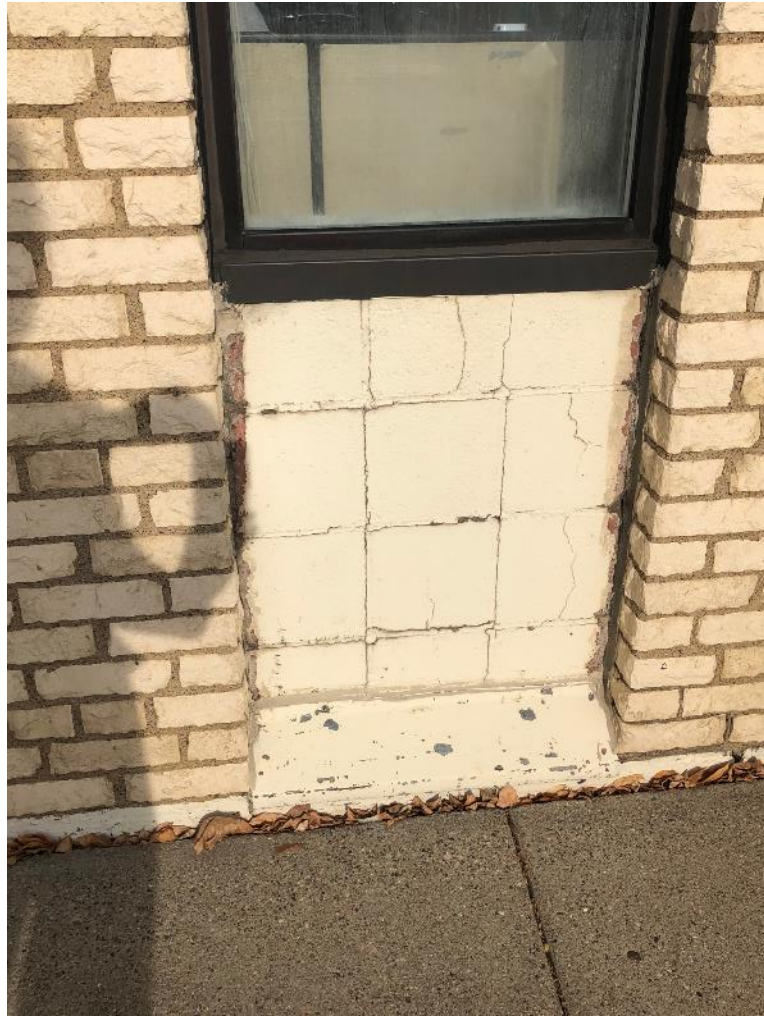
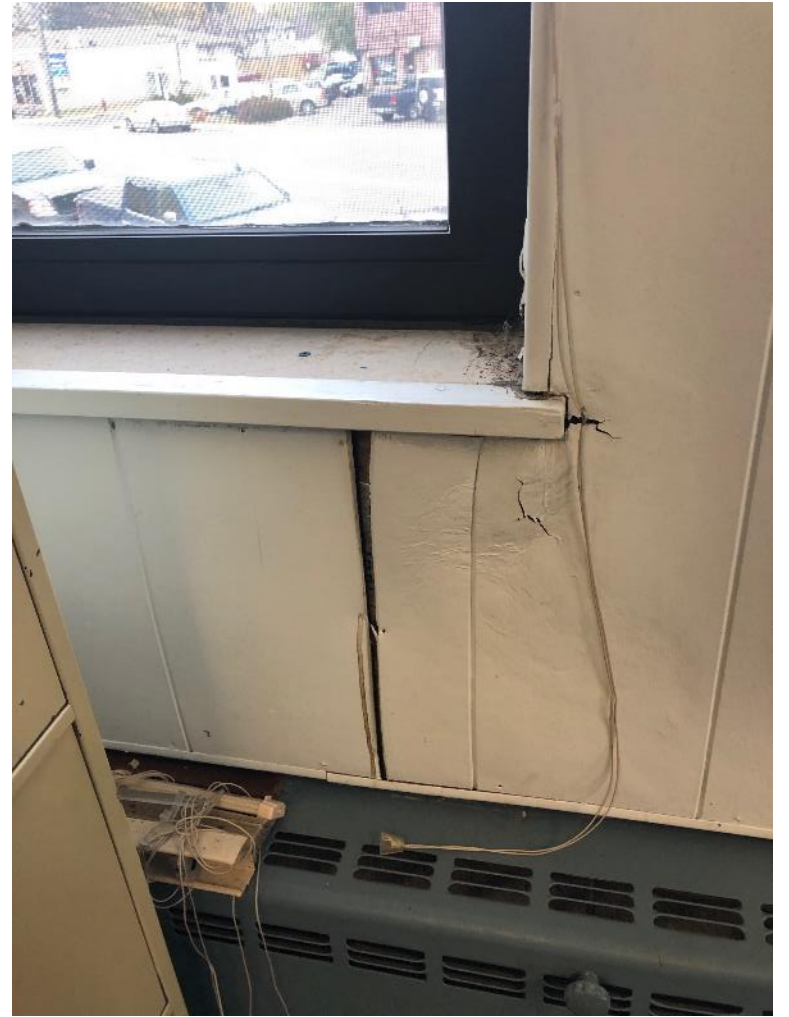
Evidence of Exterior Wall Failure / Water Intrusion
